# Manhole Inspection Summary

Manhole # S29AA1024MH

Insp Date: **12/13/06 8:47 AM**

**Location** Address: **3447 KESWICK RD**

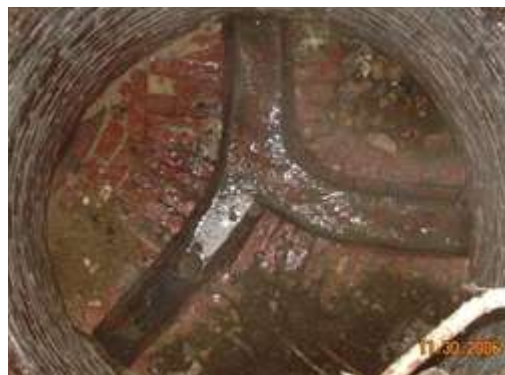
Top View

Bench and Channel debris.

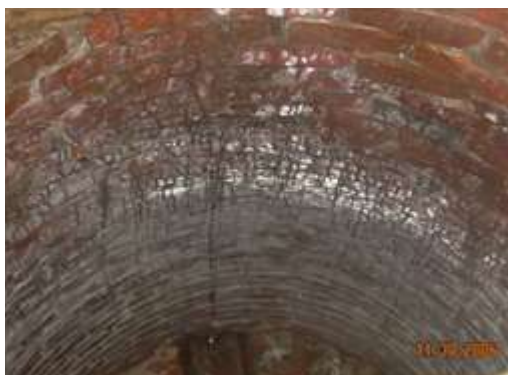
Defect

Corbel and Barrel infiltration.

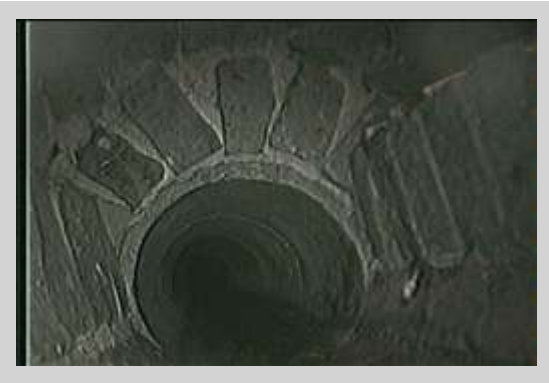
### 8 in. Circular Gravity Sewer Pipe Out @ 12 O'Clock

Invert Depth: **9.97** (ft.) Flow Characteristics: **Fast**

Deposits: ☒ None ☐ **Mud** ☐ Sludge ☐ **Debris** ☐ Grease

Infiltration: **None** Pipe Seal Cond: **Unknown**

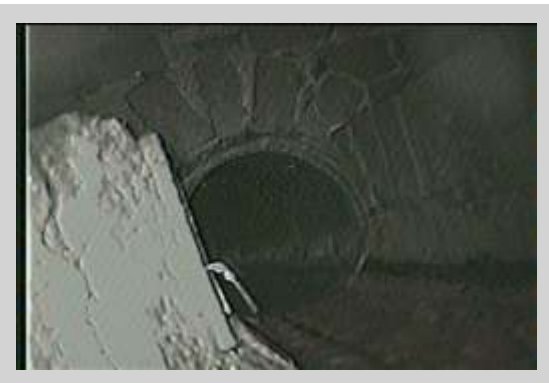
### 8 in. Circular Gravity Sewer Pipe In @ 3 O'Clock

Infiltration: **Evidence** Pipe Seal Cond: **Unknown**

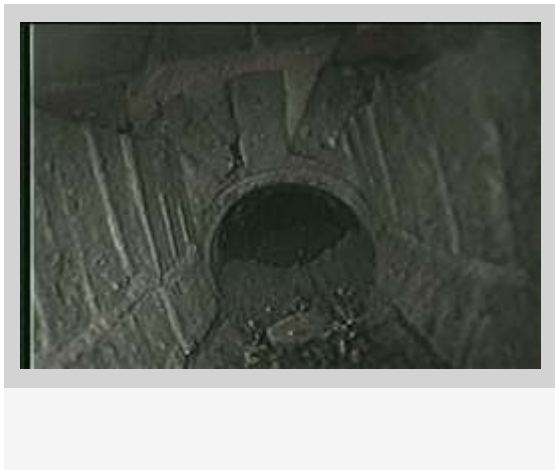
6 in. Circular Gravity Sewer  
Pipe In @ 7 O'Clock

Deposits: ☐ None ☒ **Mud** ☐ Sludge ☒ **Debris** ☐ Grease

Silt Depth: **2** (in.) Deposits Extent: **Medium**

Infiltration: **Evidence** Pipe Seal Cond: **Cracked**
